# Gully Erosion Study in Bida Town, North-Central Nigeria Using Integrated Geoscience Techniques

Okolo, S.I. and Amadi, A.N.

Department of Geology, Federal University of Technology, Minna, Niger State.

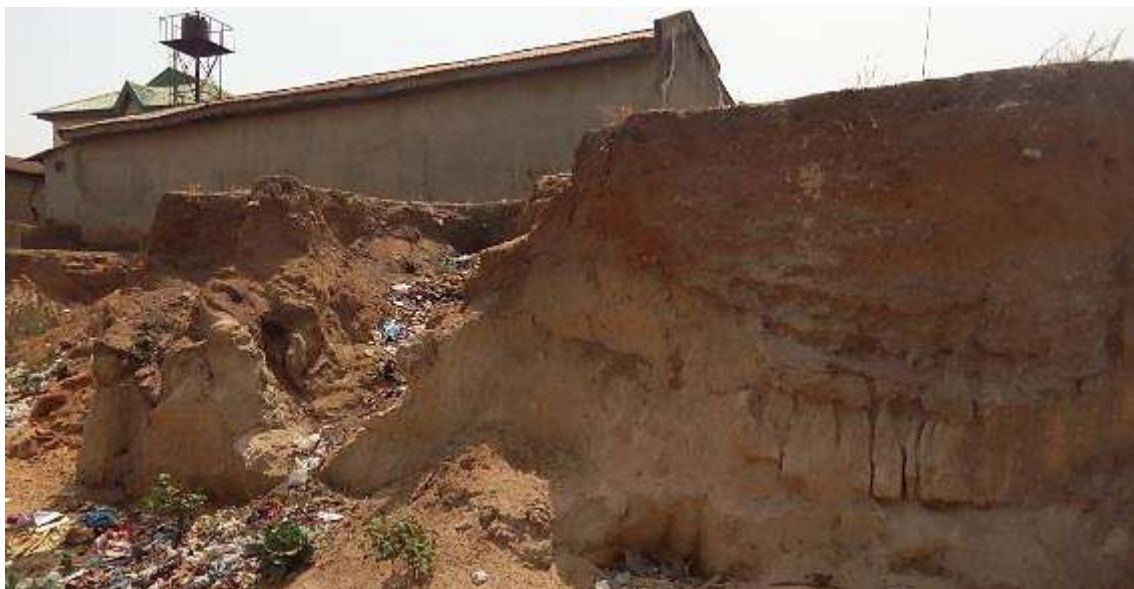
Plate 2: Gully erosion site at Gbongbofu area of Bida Town, Niger State

unconsolidated and friable. At the bottom is light-brown sandstone which is medium grained sand. The width of the gully erosion ranged from 35 metres to 50 metres. At Low-Cost area, two major layers of sandstone that were observed. The top most layer is greyish in colour and the texture is fine grained. The second layer is light-brown and it is medium grained in texture. The gully erosion site at Gbongbofu is already threatening the buildings in the vicinity and is currently used to dump refuse (Plate 2). The situation is the same at Dokoza gully erosion site as some nearby buildings has been abandoned by their owners due to ravaging gullies leading to the development of cracks on the walls of the building, which are widening day by day (Plate 3).

Construction of concrete terracing of gully affected areas is recommended to mitigate the impact. It will also restrict the widening of the existing and new gullies in the study area. Trees, plants and cover crops should be planted around the bare land in the study area. This is because low groundcover leads to increased amount of soil loss through run-off arising from heavy rainfall. Proper drainage system should be constructed and dumping of wastes at gullies sites should be discouraged by enlightening the people. Drainages should be constructed on both sides of roads in Gbongbofu and Low-Cost areas, as it will go a long way in preventing flooding and erosion in the area.

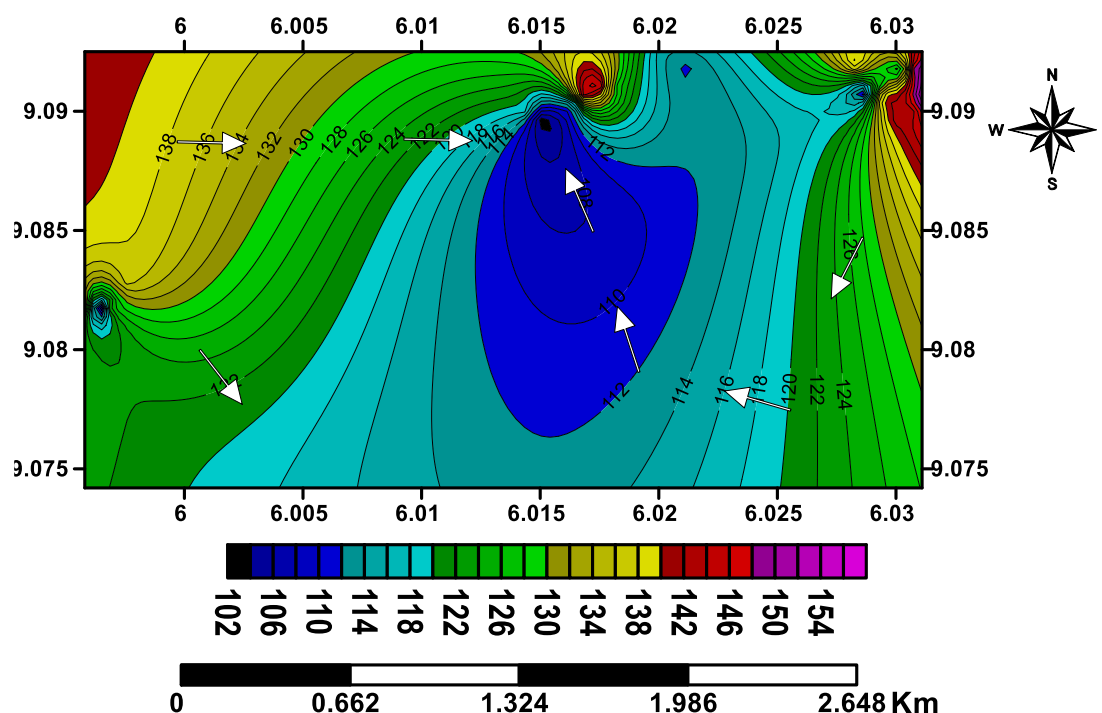
Figure 3: Groundwater flow direction

The depth to water in the study area ranged from 1.4 m to 6.9 m. The groundwater system in the area flows towards the central portion of the study area (Figure 3). When water table intercepts the ground surface, a wetland, spring, pond or fadama is formed (Amadi *et al.*, 2013). Bida Town has experienced increased rainfall in the last decade due to climate change and the propensity of the water to begins to erode the loose and friable sandy formation in the study area cannot be overemphasised. The shallow

groundwater table, the intensity of the groundwater flow and the saturation of the soil media enhances the erodibility of the formations in the study area. Groundwater flows from areas of high hydraulic head to areas of low hydraulic head in accordance with Darcy's law of groundwater movement. The intensity of flow coupled with the saturation concept of the subsurface lithologies can result to the formation gully erosion in non-plastic and friable soils (Alao and Amadi, 2012).

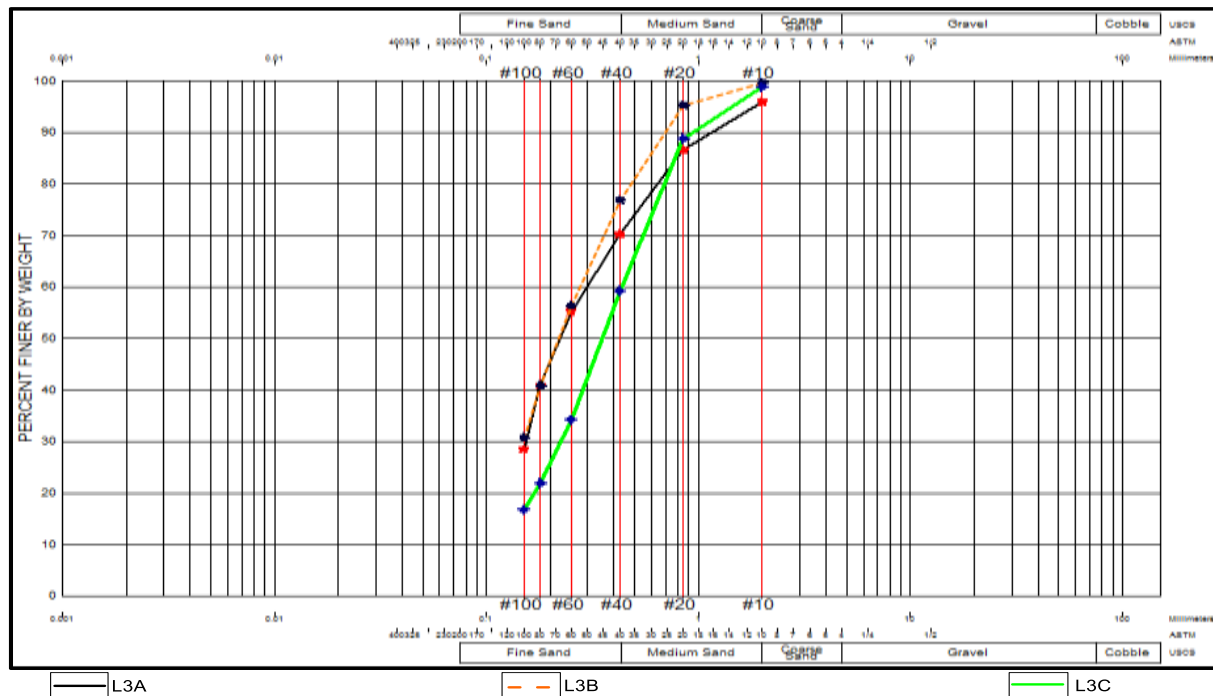
Figure 4: The Particle Size Distribution Curve for soil samples (L3A, L3B and L3C) at Gbongbofu area

The result of the sieve analysis (Figure 4) indicates that the study area is dominated by fine grained to medium grained sandy soil. The hydraulic properties of sandy formation (high porosity and permeability and non-plastic) differentiate it from other soils. The absence of clay within the

sandstone formation is the reason for the lack of plasticity of the soils in most locations. This is also the reason why there are more active erosion sites in Bida than in Minna. Geology of the area is a major contributing factor to geohazards such as gully erosion.

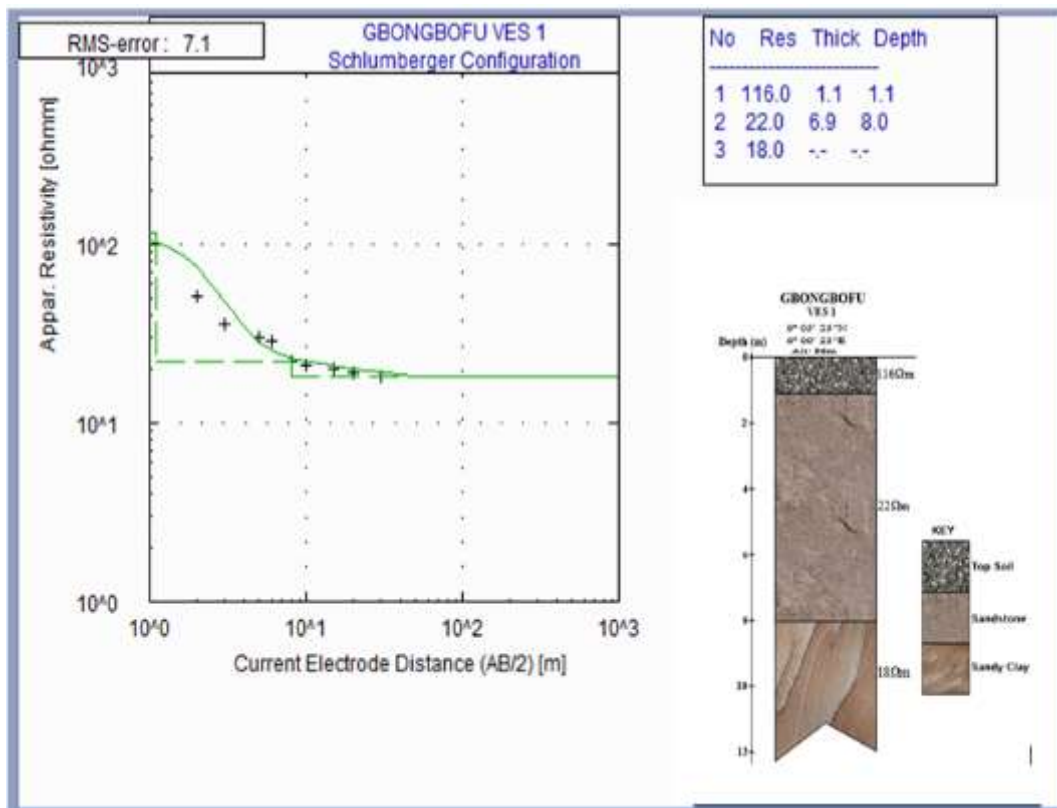
Figure 5: Vertical Electrical Sounding Curve at Gbongbofu Gully Erosion Site

Results of the 1D Vertical Electrical Sounding (Figure 5), reveals 3 geoelectric layers at Gbongbofu gully erosion site, which depicts the lithological units. The dominant curve type for the study area is Q type. The first geoelectric is the top soil, the

second geoelectric layer is sandstone formation while the third geoelectric layer is sandy-clay/clayey-sand formation. These 1D geoelectric layers correspond to the 2D electrical sounding that was carried in the same study area. Top-soil is the first layer

followed by second geoelectric layer, which are the gullible layer as a result of saturation and intensity of groundwater flow and heavy rainfall enhances the erodibility of the second layer. The first and second geoelectric layer are susceptible to

erosion because of lack of binding/cementing materials. The third layer may be slightly resistant to erosion due to the presence of clayey materials which are completely absent in the first and second layer (Figure 5).

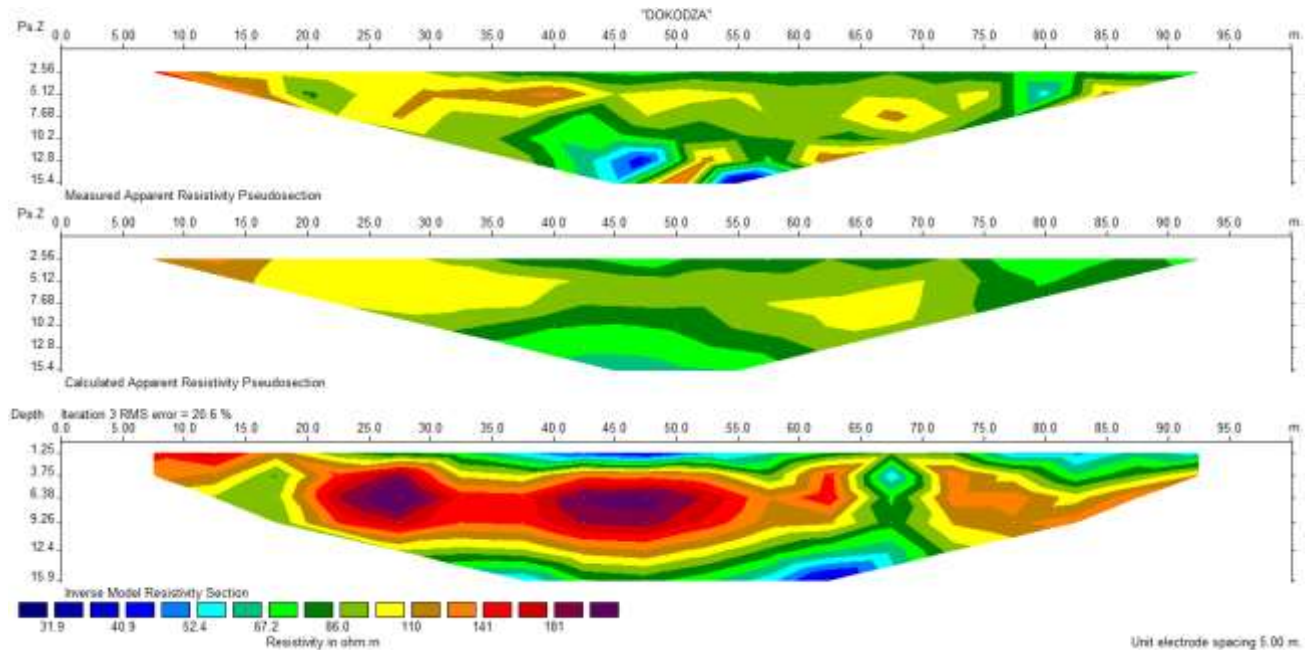
Figure 6: 2D Transverse at Dokoza Gully Erosion Site

The inverted 2D resistivity sections of Dokodza show intermediate to high resistivities at the surface in the first part of the section in the profile distance interval of 5m to 60m (Figure 6). This portion of the profile corresponds to fine to medium grained sandstone. These formation could provide rapid infiltration paths and hence increased vulnerability of the sediments to surface runoff. Underlying the high to intermediate resistivities is the layer

flanked by zones of significantly lower resistivities indicating zones of sandstone saturated with water. At the profile distance between 65m to 70m there exist an intermediate resistivity of about 67  $\Omega$ m corresponding to silty-sand/clay-sand formation. The soils at the first and second layer are prone to erosion because of its lack of cohesiveness (non-plasticity and friable).

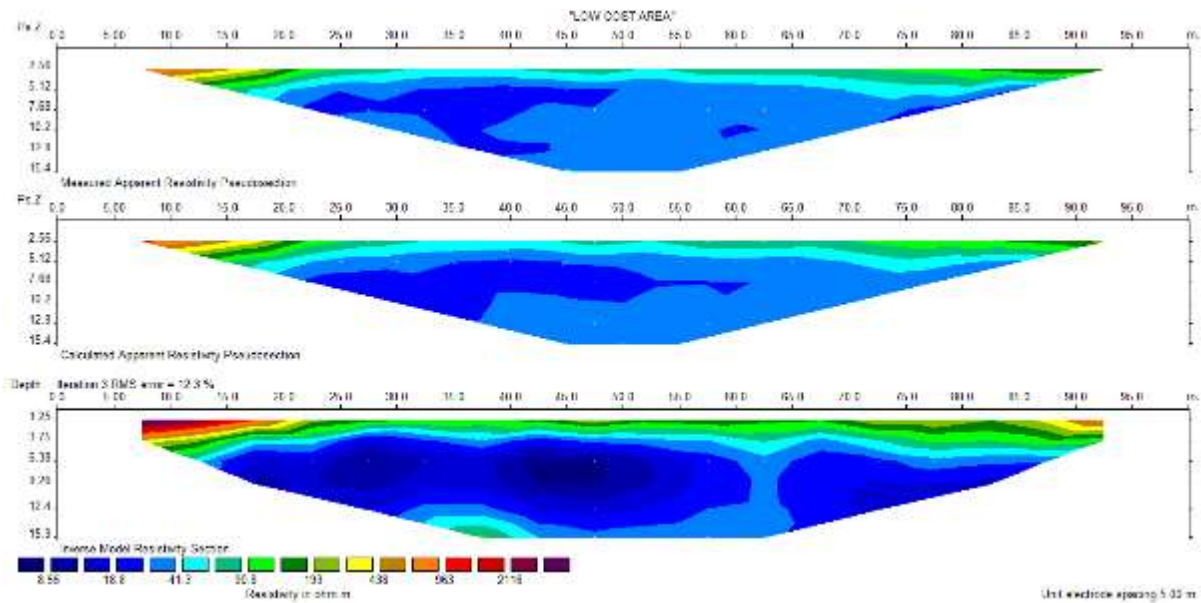
Figure 7: 2D Transverse at Low-Cost Gully Erosion Site in Bida Town

The 2D pseudo section and inverted resistivity sections of the Low-Cost (Figure 7) show moderate resistivity value of 90  $\Omega\text{m}$  at the surface indicating loose sand. A region with low resistivities range of about 8  $\Omega\text{m}$  to 50  $\Omega\text{m}$ , corresponding to groundwater saturated zone, is visibly underlying the surface layer with depths reaching over 15 m. This is the region the highest vulnerability to gully erosion due to the friable top soil formation is been grasually eaten up by the high intensity of groundwater flow from the saturated zone which is directly overlain by the top-soil. The problem is further compounded by high rainfall arising from climate change as well as lack of drainage system in the study area.

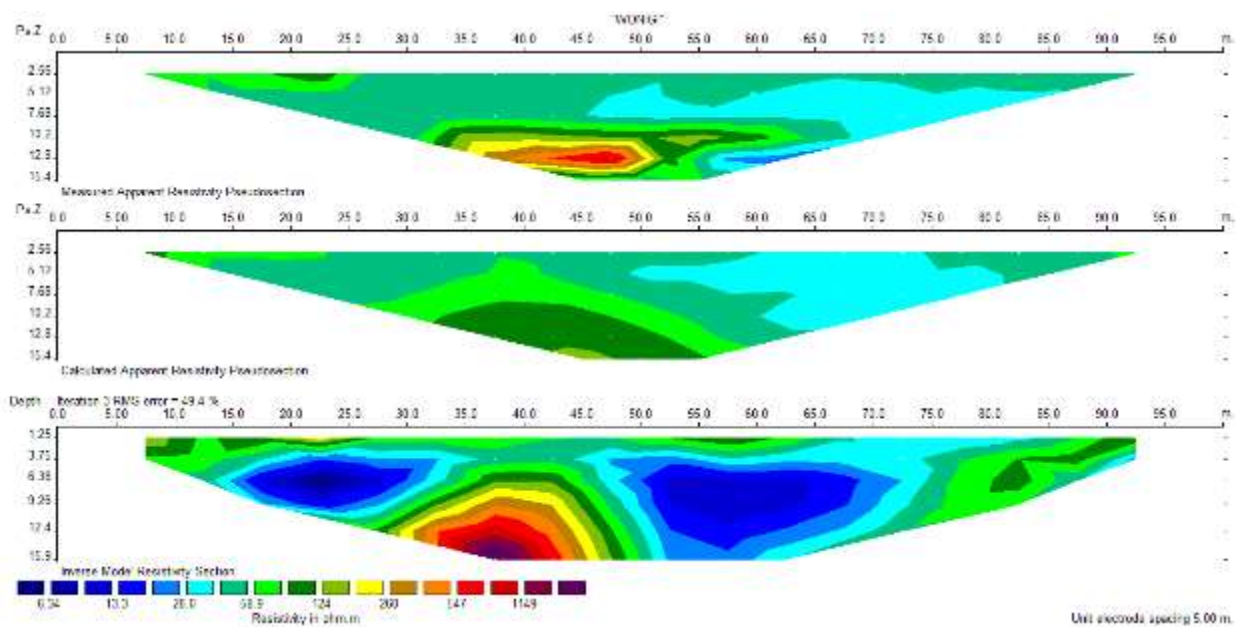
Figure 8: 2D Transverse at Wonigi Gully Erosion Site in Bida Town

The 2D inverse model resistivity section of Wonigi profile (Figure 8) shows a well-

defined highly resistive anomaly at the profile distance of 30m to 45m intruding two low resistivity portion at the 5m to 30m and 45m to 80m on the surface profile. The significantly lower resistivities of 6  $\Omega\text{m}$  to 20  $\Omega\text{m}$  extending to the depth range of 3.7m to above 15m are indicating zones of saturated formation. This findings further justify the results of the pseudosection, sieve analysis, moisture content, Atterberg limits, maximum dry density and optimum dry density. The synergy of these geoscience techniques (geological, hydrogeological, geotechnical and geophysical) in geohazard (erosion) studies has been efficiently and effectively demonstrated in this study.
