## Integrated Geophysical and Geochemical Methods for Environmental Impact Assessment of a municipal dumpsite in King Williams town, Eastern Cape, South Africa

### Abstract

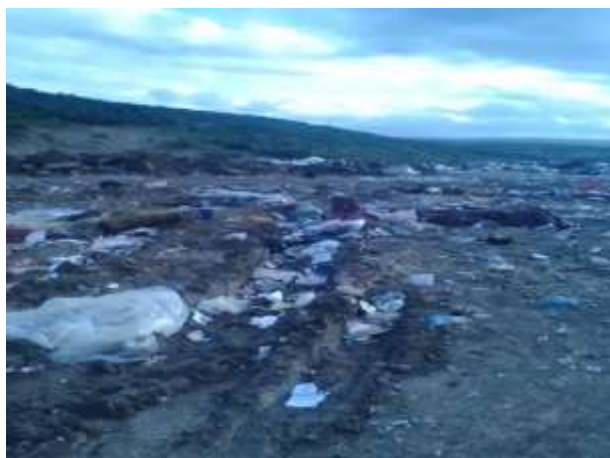
Figure 1a: Dumpsite surface composition viewed from the South

and latitudes  $32.8525 - 32.8495^{\circ}$  S, covering an area of about  $0.30\text{km}^2$  (Figure 1a – 1d). The landfill is an abandoned quarry in which landfilling started in 1983 by open dumping. The land fill receives a mixture of municipal, commercial, and mixed industrial wastes with hazardous and non-hazardous constituents. These often go into the landfill unsorted and releases large amount of gases, particles, and leachate into the surrounding soil and ground water.

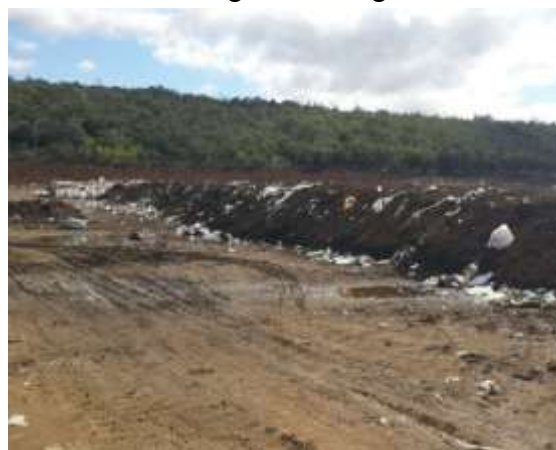
Figure 1b: Dumpsite surface composition viewed from the East

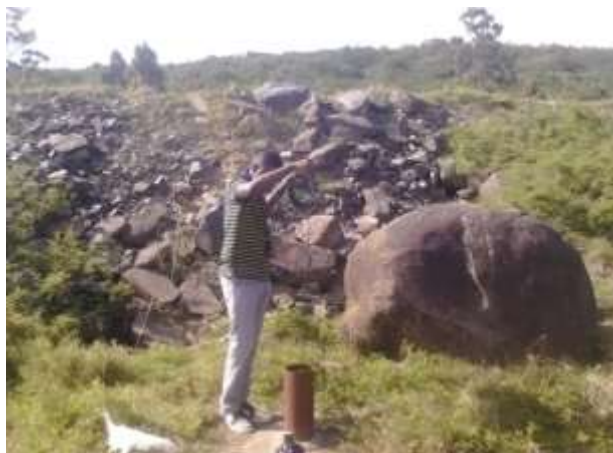
Figure 1c: Groundwater monitoring borehole located south of the landfill

Water containing dissolved contaminants from the landfill is collected and contained in the leachate pond. There are two groundwater monitoring borehole located

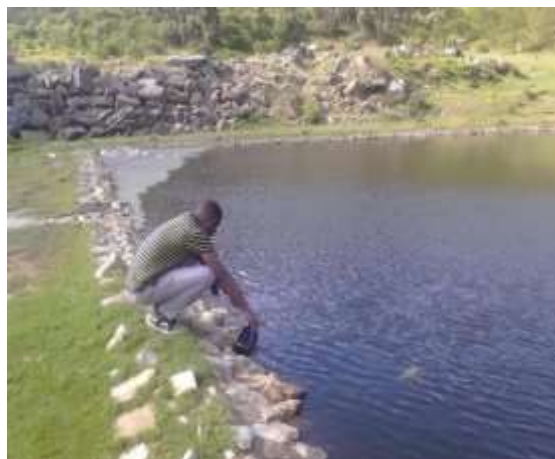
Figure 1d: Leachate pond located southwest of the landfill
